REMOVAL SITE EVALUATION OF MERCURY IN SOIL AND GROUNDWATER
AT FORMER MERCURY FULMINATE FACILITY

RICHMOND FIELD STATION

Richmond, California

May 21, 1990

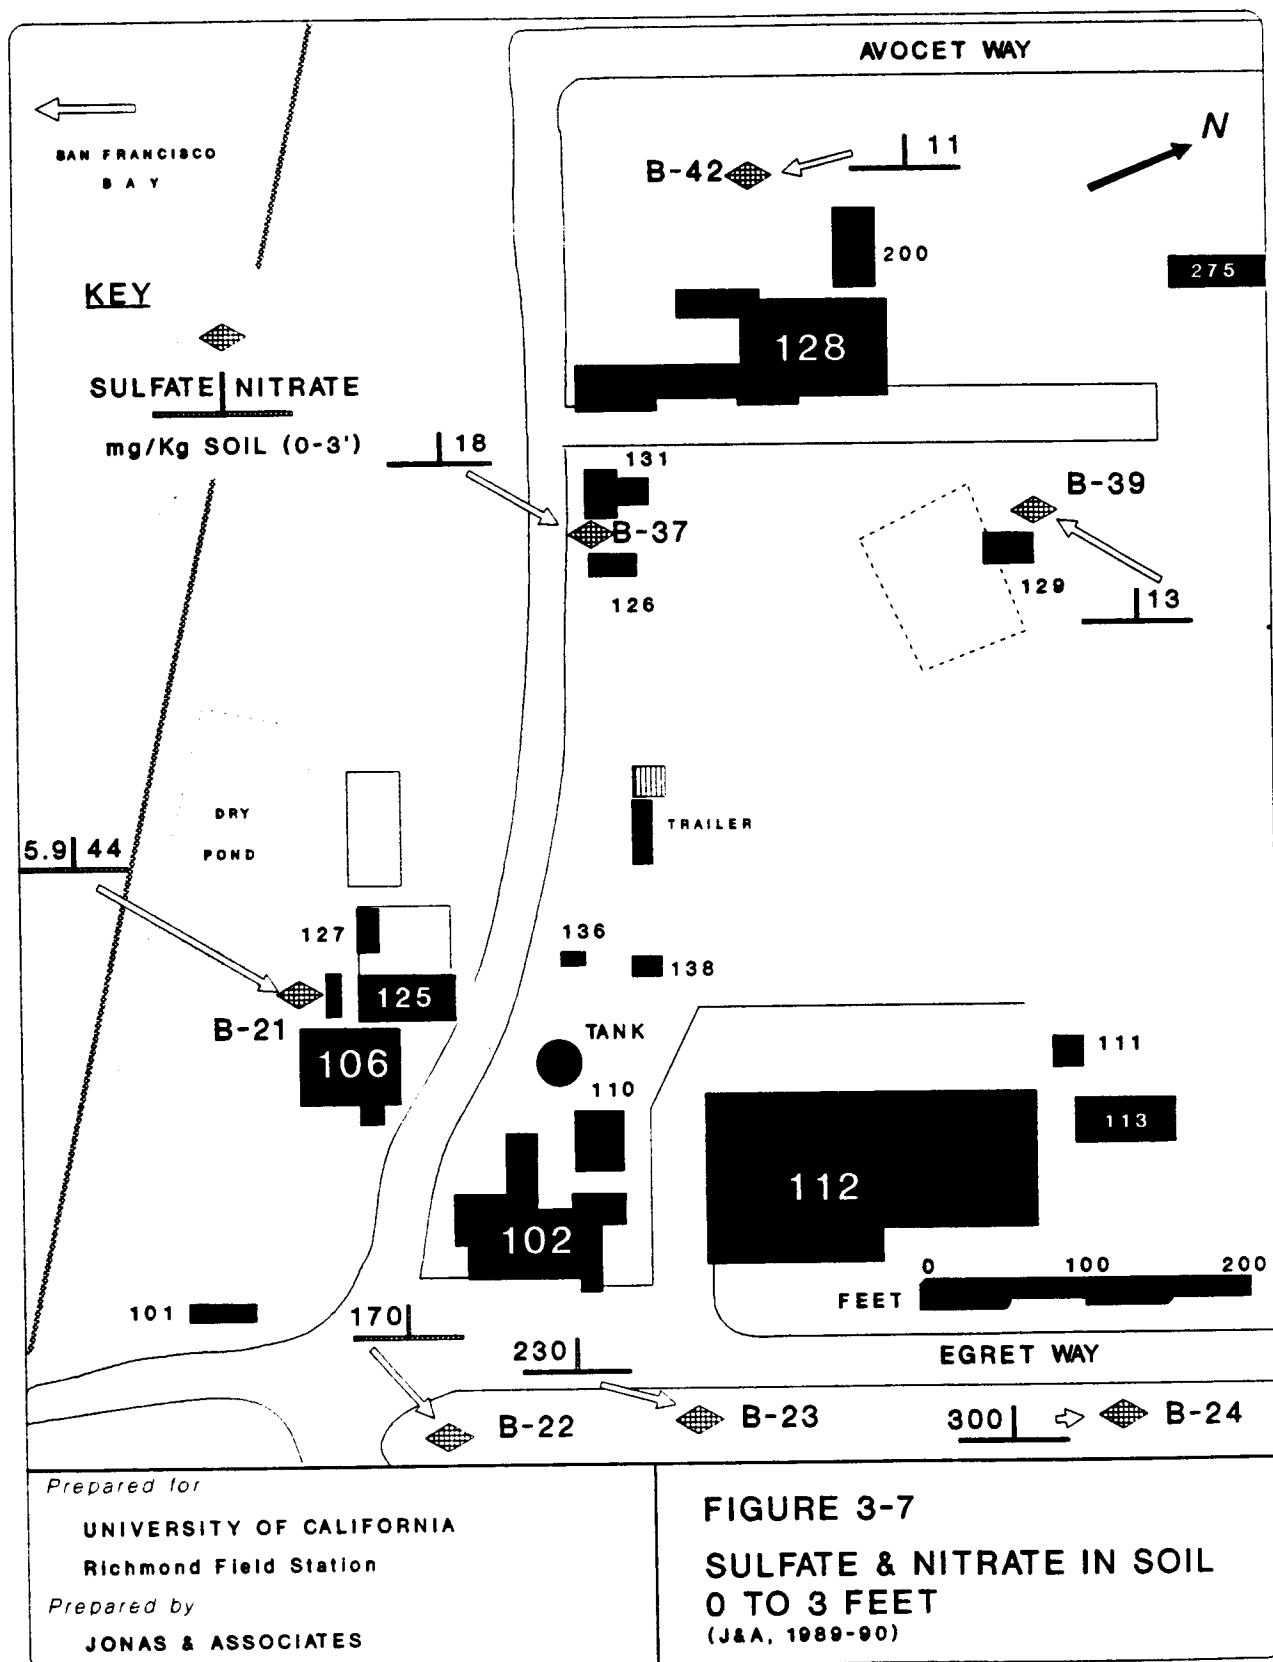
FIGURE 3-8
COPPER IN SURFACE SOIL
AND AT 0-3 FEET
 (J&A, 1989-90)

Table 3-5 and Figures 3-8 and 3-9 present the sample locations and analytical results for copper and zinc concentrations in composite samples B-12, B-18, B-38 and B-39. In addition, two surface samples were collected adjacent to the sample locations for B-18 and B-39. All samples were below the TTLC level of 2,500 ppm for copper, and 5,000 ppm for zinc.

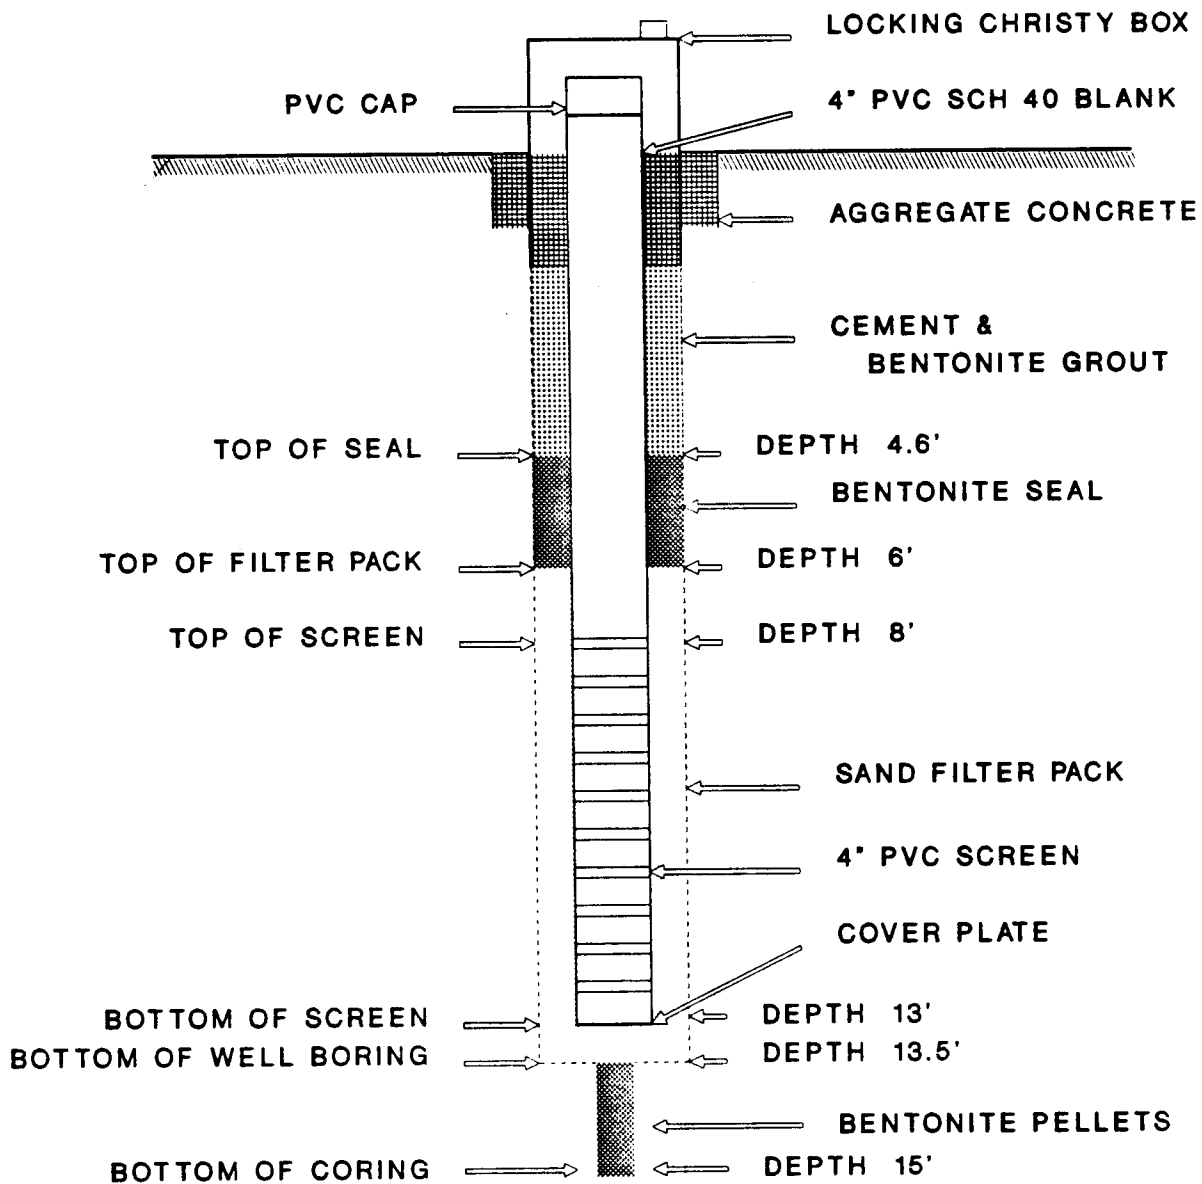
Figure 4-1 MW-1 CONSTRUCTION DETAILS

PROJECT NAME: UNIVERSITY OF CALIFORNIA RICHMOND FIELD STATION
BORING LOCATION: Behind Building 105 DATE: 2-25-90 BY: RJ

During the drilling of monitoring wells MW-A and MW-1, groundwater was first encountered at depths of 9.0 to 7.5 feet below ground surface, respectively. In the borehole for monitoring well MW-1, below a thick layer of clay, the first water-bearing unit composed of sand was located at a depth of 8 to 13 feet. This water-bearing unit was then screened. After monitoring well MW-1 was installed and allowed to equilibrate, the water level rose to 4.25 feet below the surface: indicating confined conditions. Because a thick clay layer exists below the surface, local groundwater probably occurs under confined to semiconfined conditions. Boring logs for MW-A and MW-1 are shown as Figures 4-2 and 4-3 in Section 4.0 of this report.

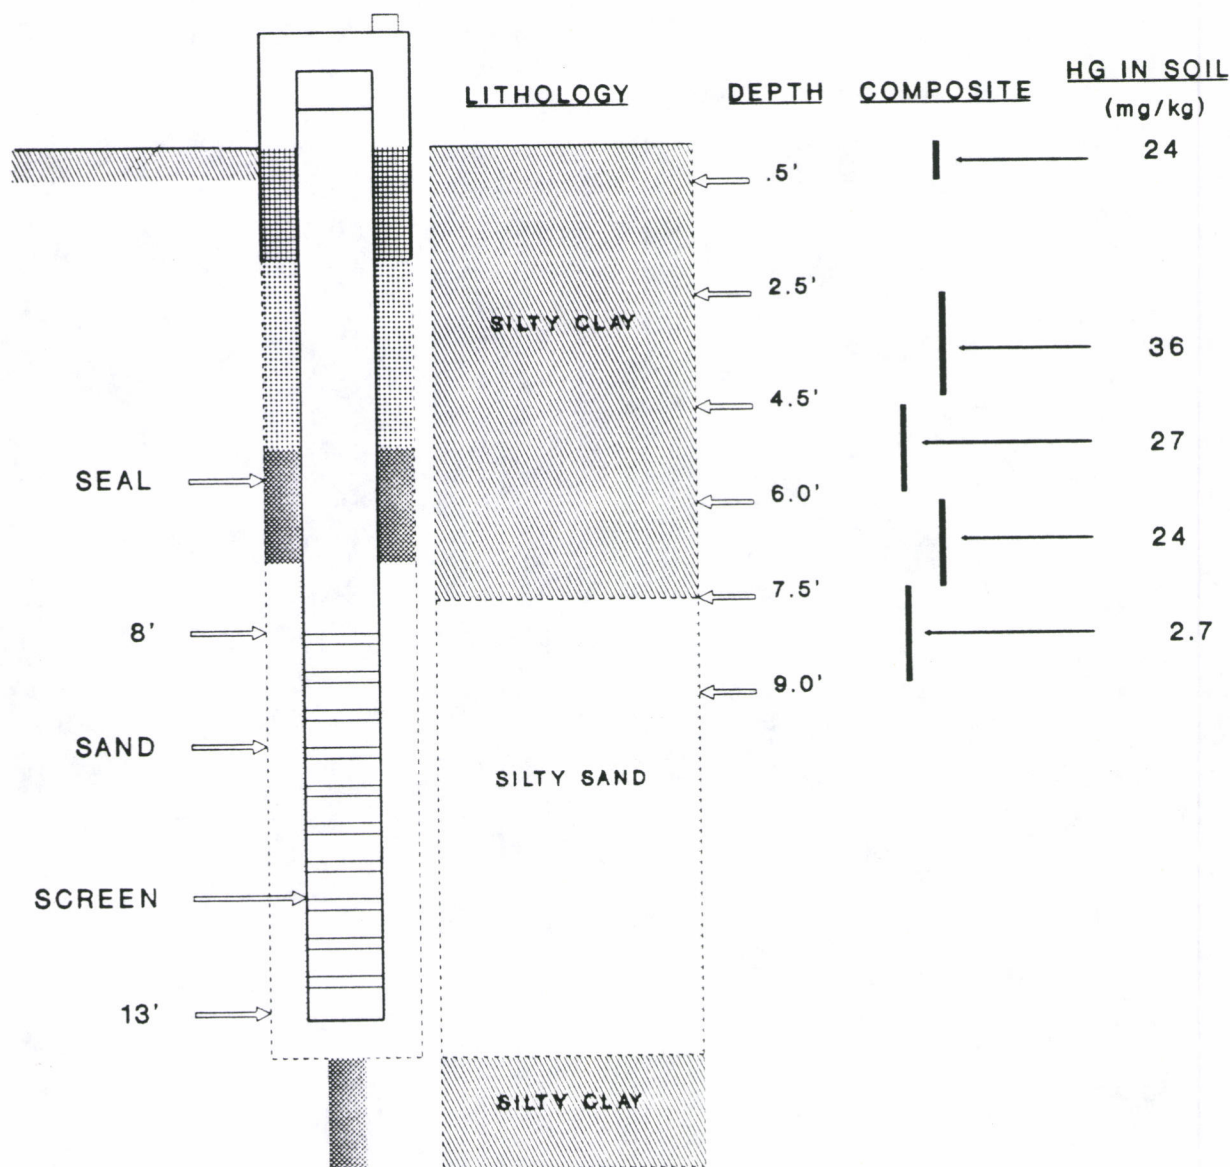
MW-1 STRATIGRAPHY AND SOIL ANALYTICAL RESULTS

PROJECT NAME: UNIVERSITY OF CALIFORNIA RICHMOND FIELD STATION
BORING LOCATION: Behind Building 105 DATE: 2-25-90 BY: RJ

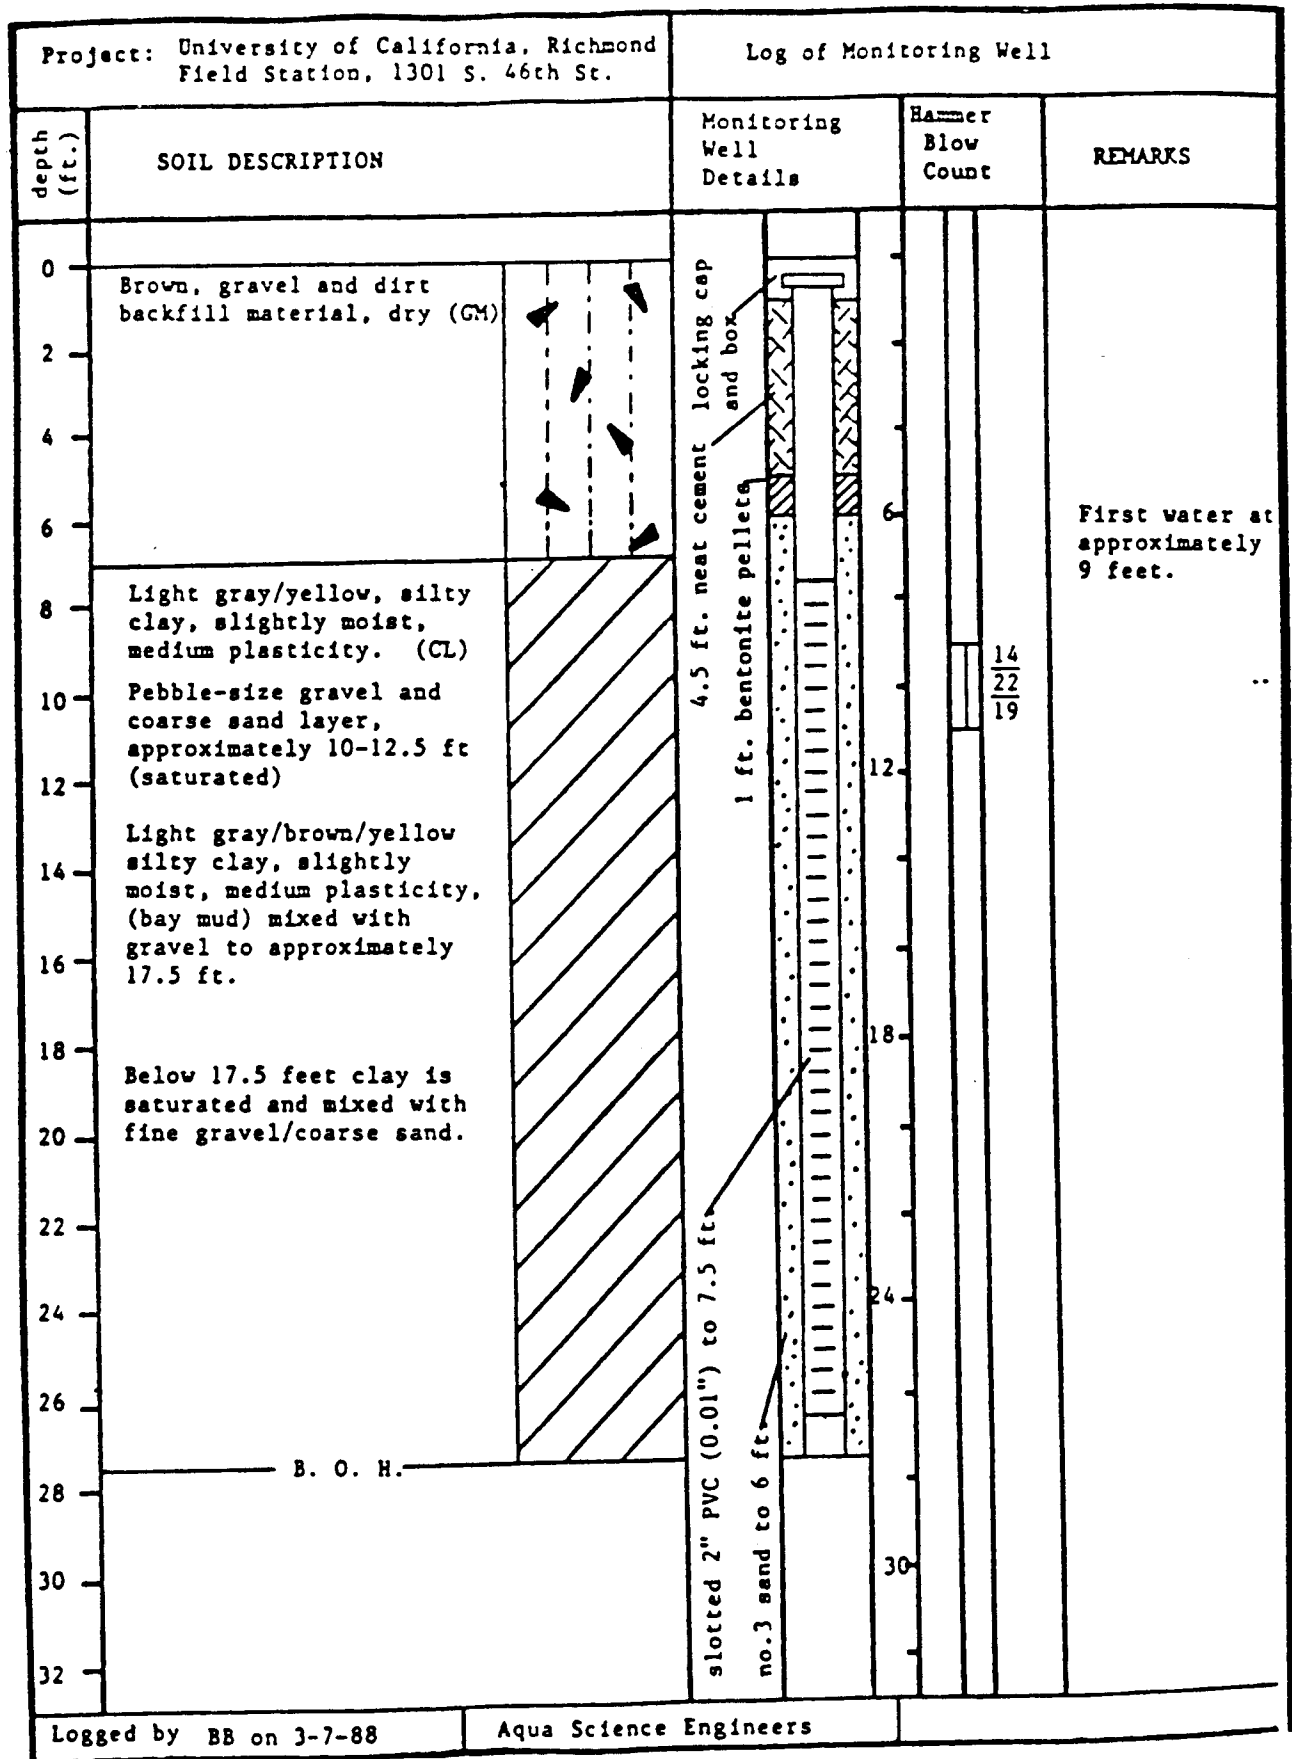
FIGURE 4-3

MW-A CONSTRUCTION DETAILS
